NAVAL FACILITIES ENGINEERING SERVICE CENTER
Port Hueneme, California 93043-4328

Technical Report TR-2040-OCN

FDS-D WET-END SURVIVABILITY POST TEST ANALYSIS

March 1995

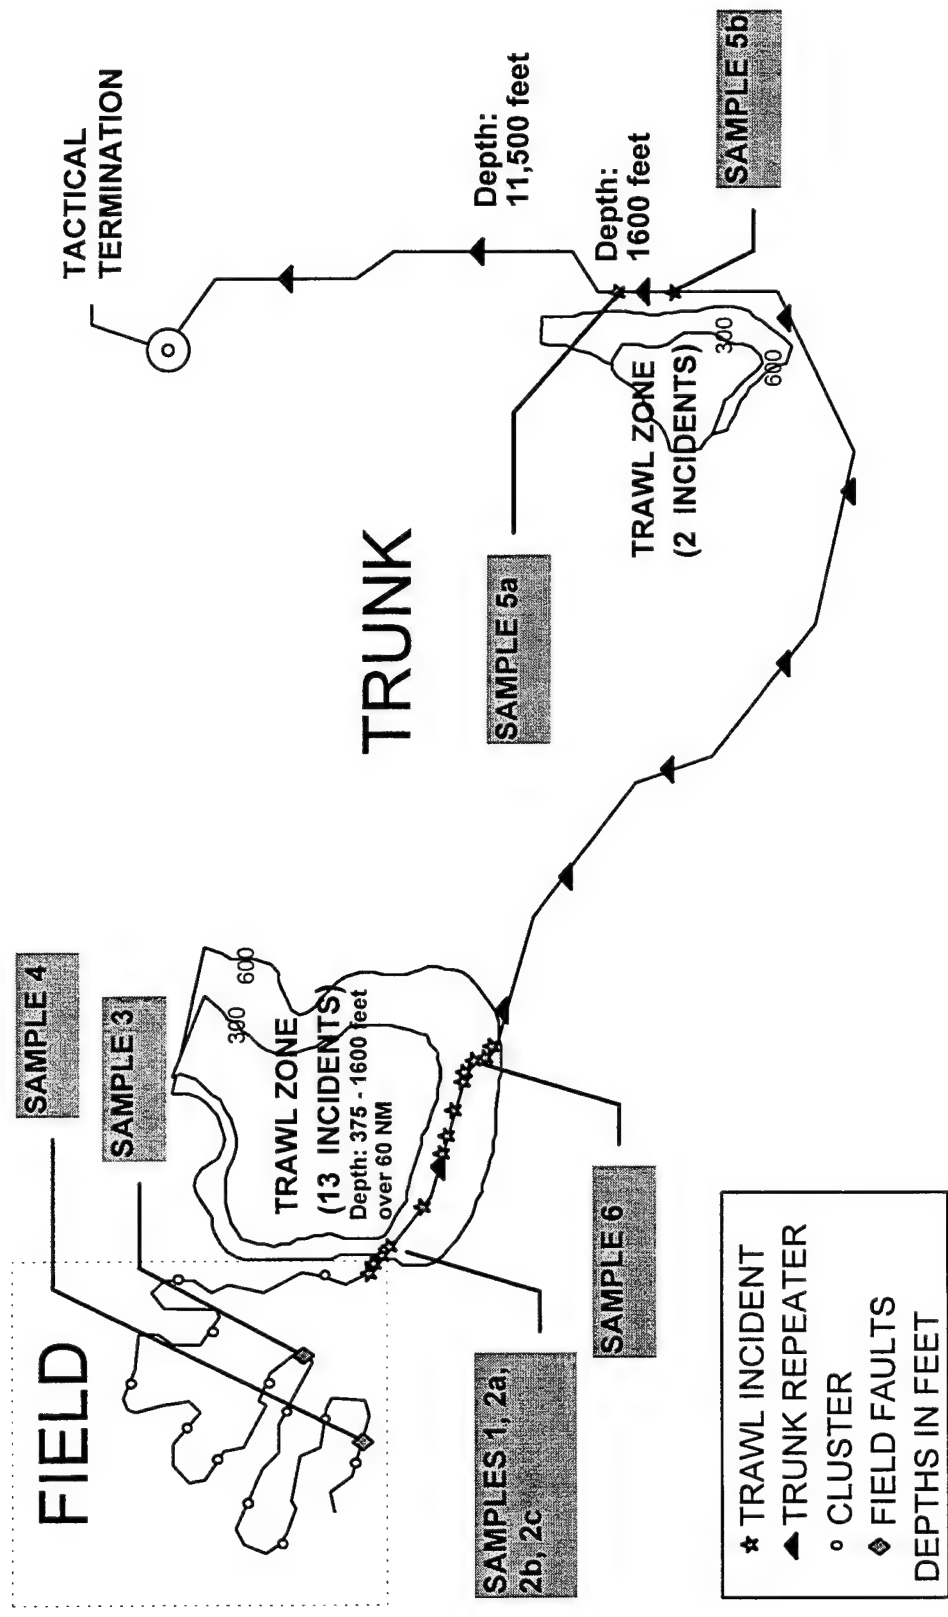
FIGURE A-1. FDS-D UWS

FAULT NO.	DATE RECOVERED/ LOCATION	DESCRIPTION
1	Recovered: 7/2/94 by T-ship Location: 1100' Depth, Appr. 5 nm shoreward of CL116.	Suspected trawl damage. Damage is a single cut in cable (0.6" x 0.4") down to steel tape. Minor groove in cable leading up to cut from one side. Green glue is visible on outside of tape. No sign of further penetration. Possible electrical failure.
2a,b,c	Recovered: 7/2/94 by T-ship Location: 1100' Depth, 4-5 nm seaward of CL116.	Suspected trawl damage. All three samples recovered within 4000' of each other with minor damage (nicks and grooves) between major damage. (2a) Deep gash down to strength member. (2b) Cut in outer jacket exposing tape. (2c) Deep groove along cable, long section where shield is exposed and green coating on outside of shield is present, one area where shield is penetrated and pushed open exposing the dielectric. Bottom: Along slope leading from bank (300-600') down to trench (1100-2000'). Electrical failure.

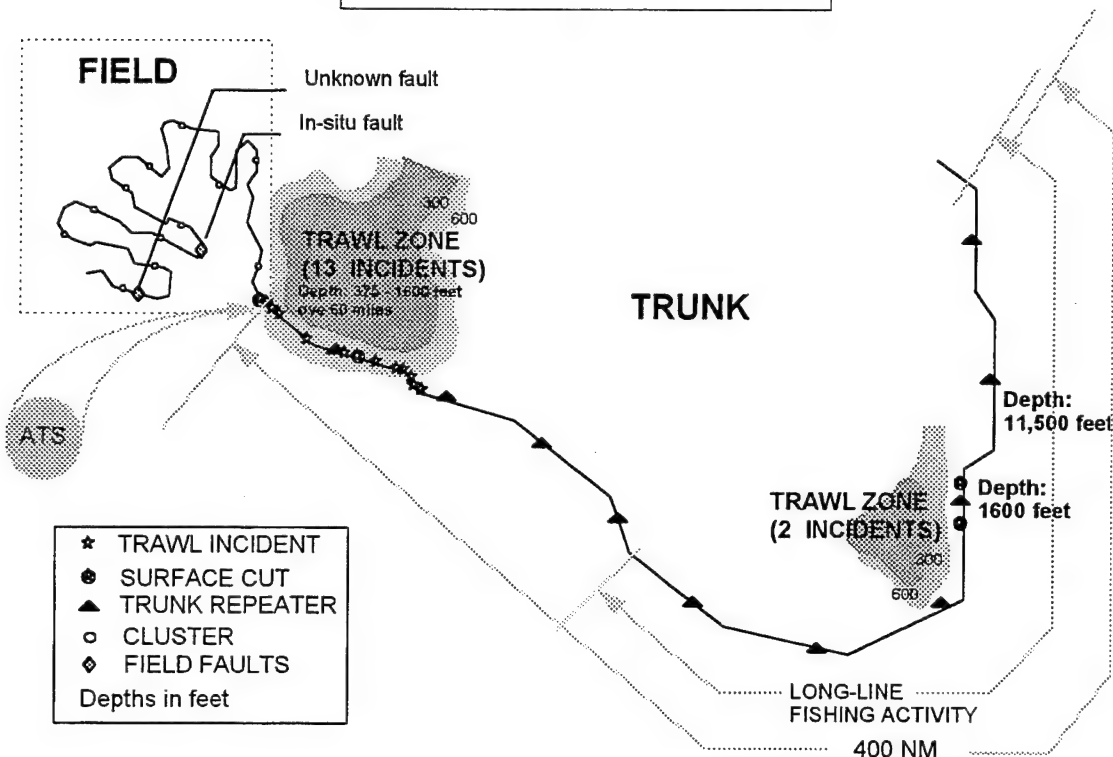
FIGURE B-1. FDS-D UWS

A trawl failure is definitive. Fifteen incidents of trawler-induced damage were documented in the UWS. A trawl failure incident is characterized by damage that results from one pass across the cable track by a trawler otterboard. It is possible a single trawler may have produced damage in more than one incident, but did so on separate passes. Failure locations are identified in Figure 1.

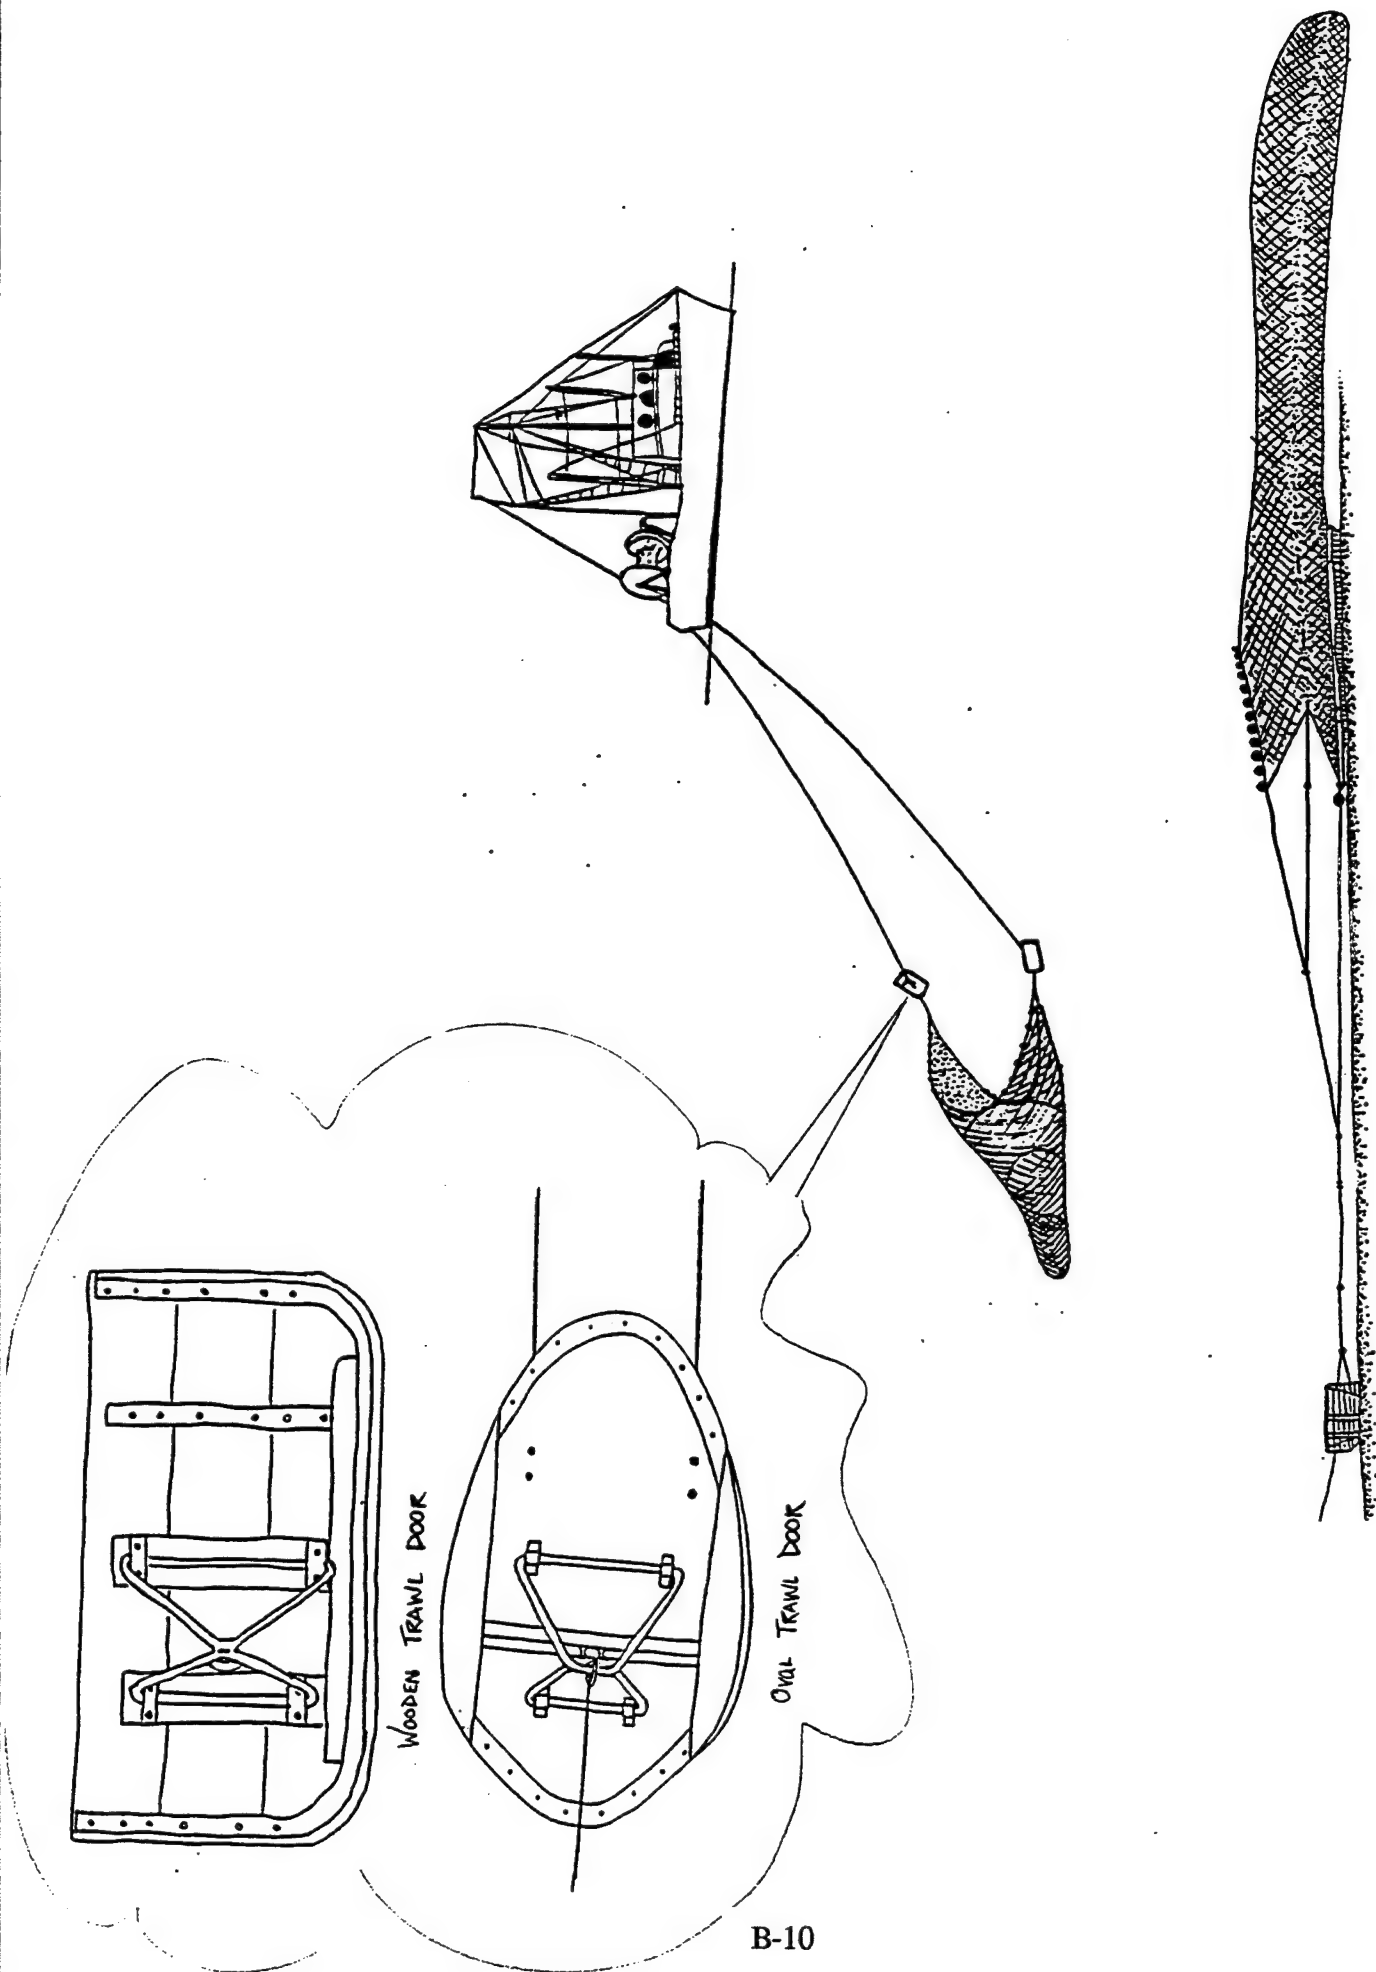
FIGURE B-8. TYPICAL TRAWLING RIG IN THE MEDITERRANEAN

Most of the cable failures (13 out of 15) occurred on the southern edge of a large, 3,000-square mile, shallow water bank. The cable track was along the edge of the bank over a length of 60 NM. The depth in this area ranges from 300 to 1650 feet, the seafloor composition is mostly mud, and the slope ranges between 0% and 10%. The cable faults were spread out over the entire 60-NM length. Approximately 40 NM of the cable track was on a flat area of the bank in a depth between 300 feet and 600 feet. The remaining 20 NM was on the slope of the bank where the depth ranged between 600 and 1800 feet. Of

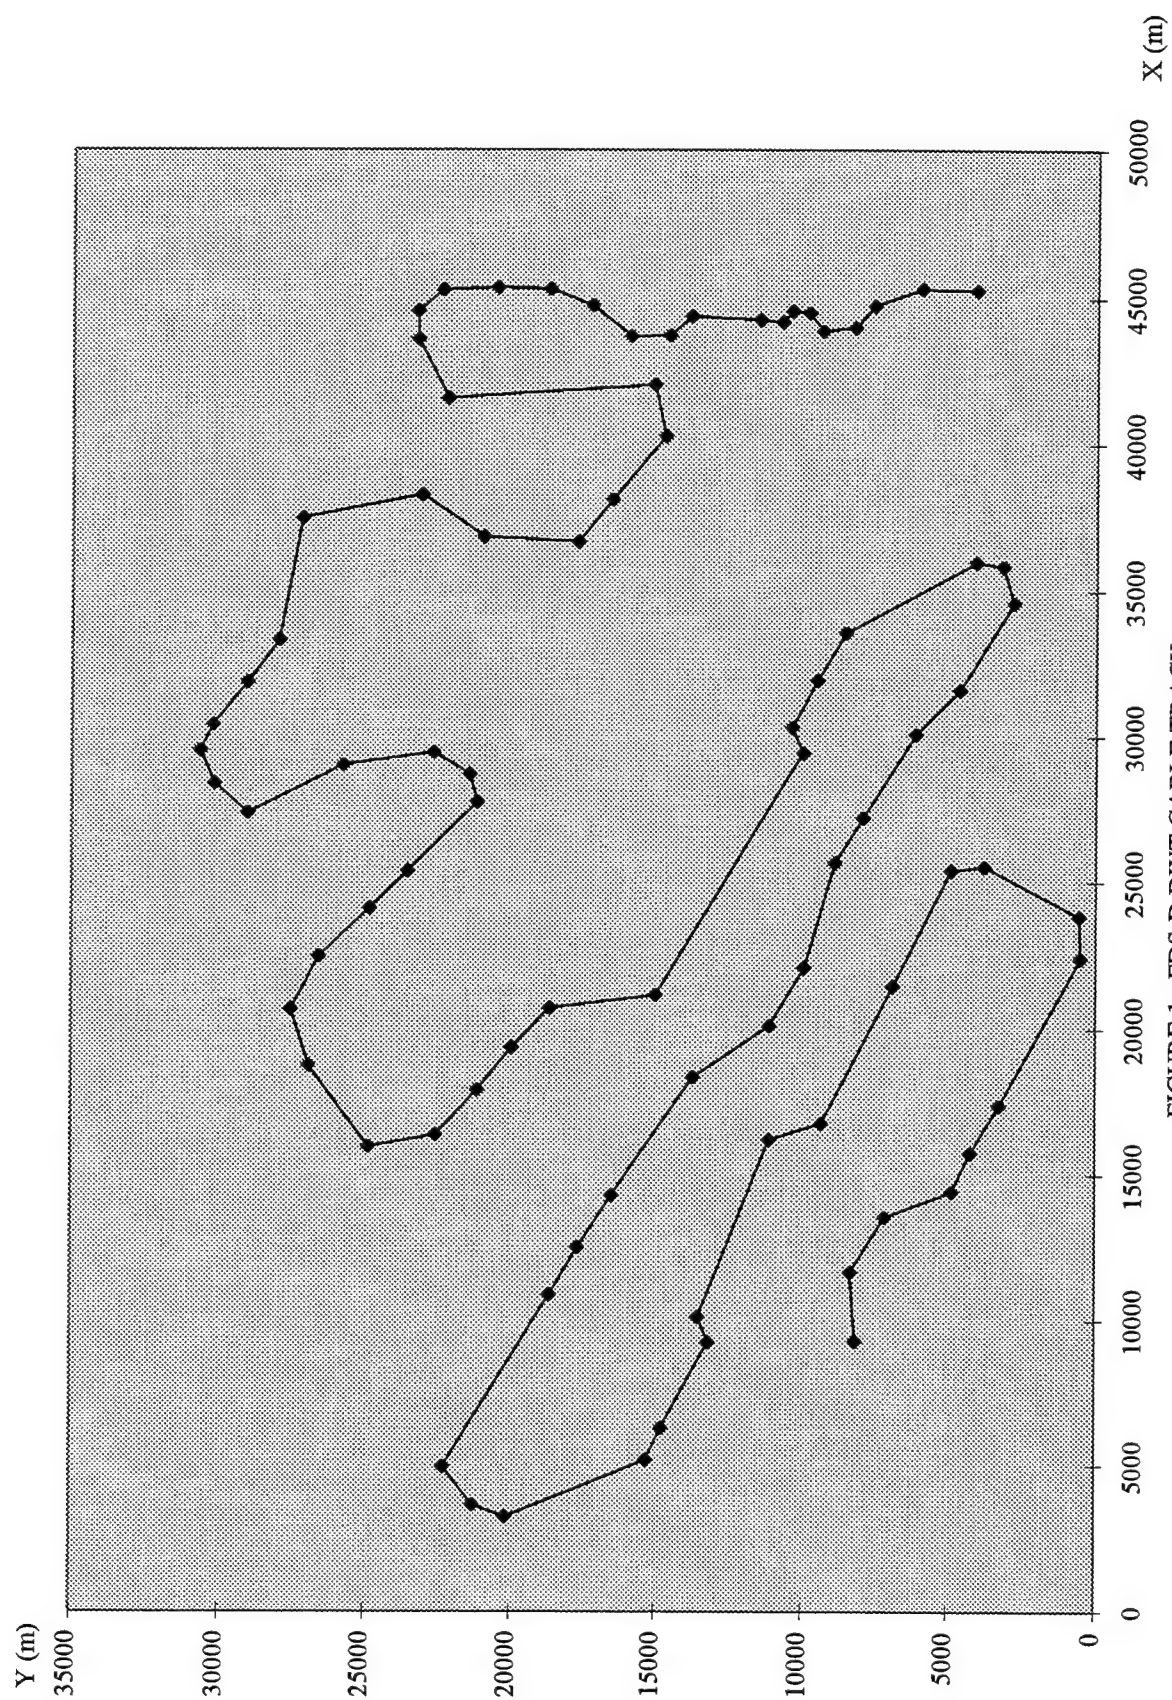
FIGURE 1. FDS-D DWT CABLE TRACK

The Ocean Engineering Division was asked to assist in analyzing a cable failure on the seafloor, particularly, how the deployment may have contributed to the failure. The cable deployment project is entitled Fixed Distributed Systems-Deployable 1 (FDS-D1) and consists of a deployed cable making a series of s-turns approximately 120 miles long (Figure 1). The cable failed in the midst of one of the s-turns; therefore, the analysis was focused on that particular s-turn, consisting of approximately 14 miles of cable (Figure 2). This section of the deployment had a cable-to-cable junction (CCJ) that was included in the analysis.

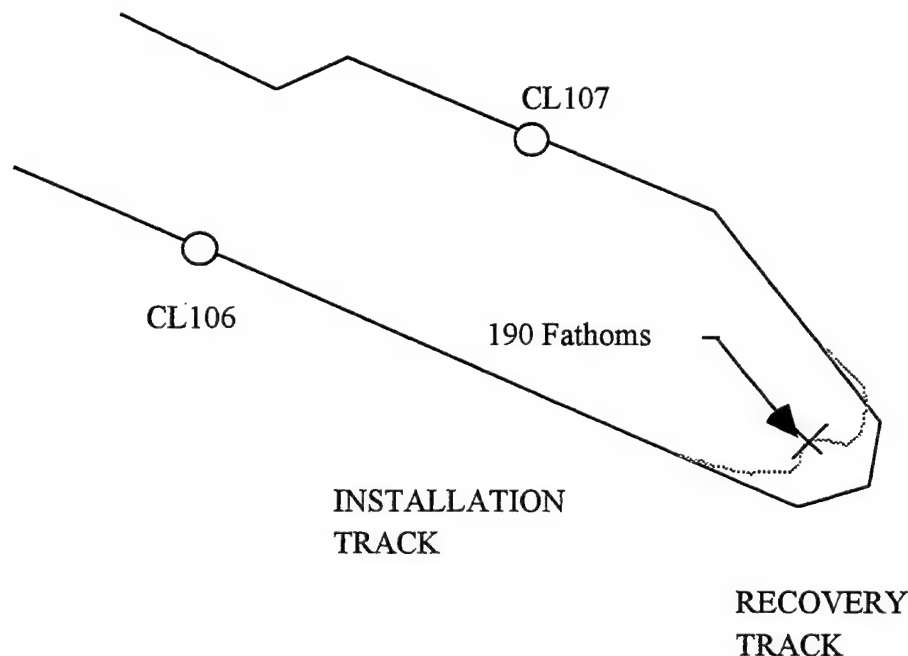
- CL108, CL107, CL106, and CL105 recovered in good condition. Total of 25 NM of DWT has been recovered in the last 24 hour period and there are 36 NM remaining at this location.
- Hydrophone spacing measurements: CL107 hydrophone H15 to H14 spacing is ____; H14 to H13 spacing is ____.
- Fault between CL107 and CL106, present since 25 July, was discovered to be a cut in the cable caused by a piece of scrap steel. The scrap steel appears to be the remnants of a filter screen from a ship (dimensions: 40"x20"x1"). The filter screen came to the surface wrapped at a hard angle around the cable. Power conductor and strength member were exposed. Fault location is 4.873 NM seaward of CL107/108 and on the inside of a 180 degree turn made during the cable deployment. Depth is approximately 190 fathoms.

Testing on the seaward side of the fault indicates remaining clusters CL101 through CL105 are operational.
